**DEPARTMENT OF TRANSPORTATION**

Contract #: 04-0120F4Cty: SF/ALA Rte: 80 PM: 13.2/13.9File #: 13.28**WELDING INSPECTION REPORT****Resident Engineer:** Pursell, Gary**Address:** 333 Burma Road**City:** Oakland, CA 94607**Report No:** WIR-007095**Date Inspected:** 09-Jun-2009**Project Name:** SAS Superstructure**OSM Arrival Time:** 2100**Prime Contractor:** American Bridge/Fluor Enterprises, a JV**OSM Departure Time:** 530**Contractor:** Oregon Iron Works Clackamas, Or.**Location:** Clackamas, Oregon**CWI Name:** Steve Barnett, Jon Nickolich**CWI Present:** Yes No**Inspected CWI report:** Yes No N/A**Rod Oven in Use:** Yes No N/A**Electrode to specification:** Yes No N/A**Weld Procedures Followed:** Yes No N/A**Qualified Welders:** Yes No N/A**Verified Joint Fit-up:** Yes No N/A**Approved Drawings:** Yes No N/A**Approved WPS:** Yes No N/A**Delayed / Cancelled:** Yes No N/A**Bridge No:** 34-0006**Component:** Hinge K Pipe Beams**Summary of Items Observed:**

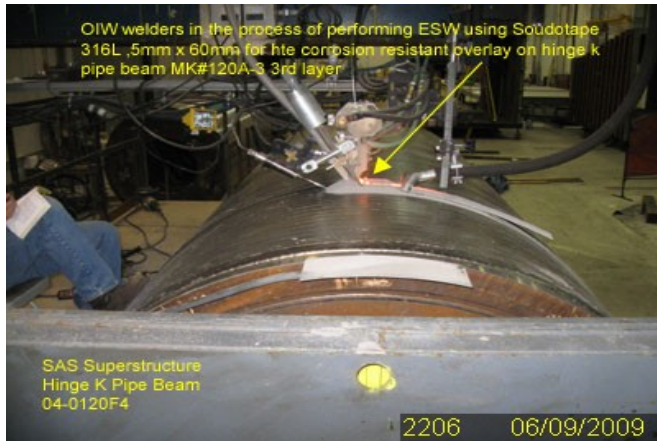
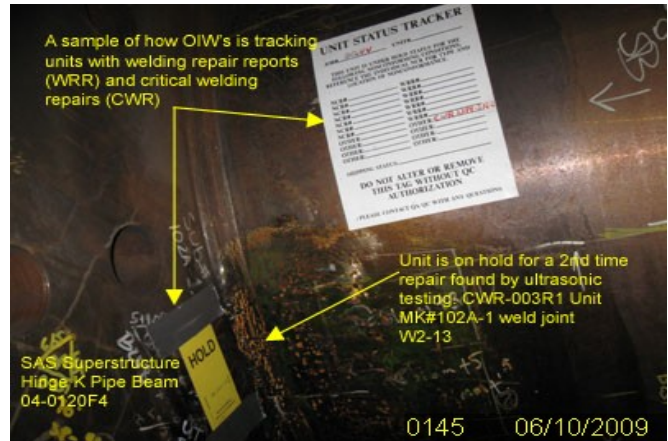
QA Inspector Brannon randomly observed OIW welder's Mr. Liam Bui ID#B10 and Mr. Yuriy Bannikov ID#B61 preping stiffener ring MK #a125 (HPS 485 W) for fit-up. Mr. Bui was observed grinding beveled edges for fit-up to hinge K pipe beam half section MK#a124-15 (HPS 485 W). The partial joint penetration (PJP) groove weld will be identified as weld joint #WM3-15. Fit-up not completed at the end of this shift.

QA Inspector Brannon randomly observed OIW qualified welder's Mr. Bounheune Savanh ID#S74 and Vincent Vu ID#V7 welding soudotape 316L stainless steel overlay to hinge k pipe beam fuse sub-assembly 120A-3. The weld joint is identified as 316L 3rd layer. Mr. Savanh and Mr. Vu was observed welding in the flat position utilizing automatic electro slag welding (ESW) overlay process with a .5mm x 60mm soudotape 316L stainless electrode, filler metal brand Soudotape class EQ316L automatic. QA Inspector Brannon observed the OIW QC CWI Inspector's Mr. Steve Barnett and Mr. Jon Nickolich verifying that the pre-heat of 20°C and welding parameters were in accordance with Welding Procedure Specification (WPS). Welding parameters observed by QA Inspector Brannon are as follows: 1200 amps, 25.9 volts and a travel speed of 267mm per minute appear to be in conformance with approved welding procedure specification (WPS 7003) revision number 0.

The following digital photograph below illustrates observation of the activities being performed.
